Observation Report

PROJECT NO. 385687.F1.01

(1) DAY: Tuesday DATE: 6/25/13 WORK PERIOD: 7:45 AM a.m. TO 11:20 PM a.m. REPORT NO. _____
p.m.

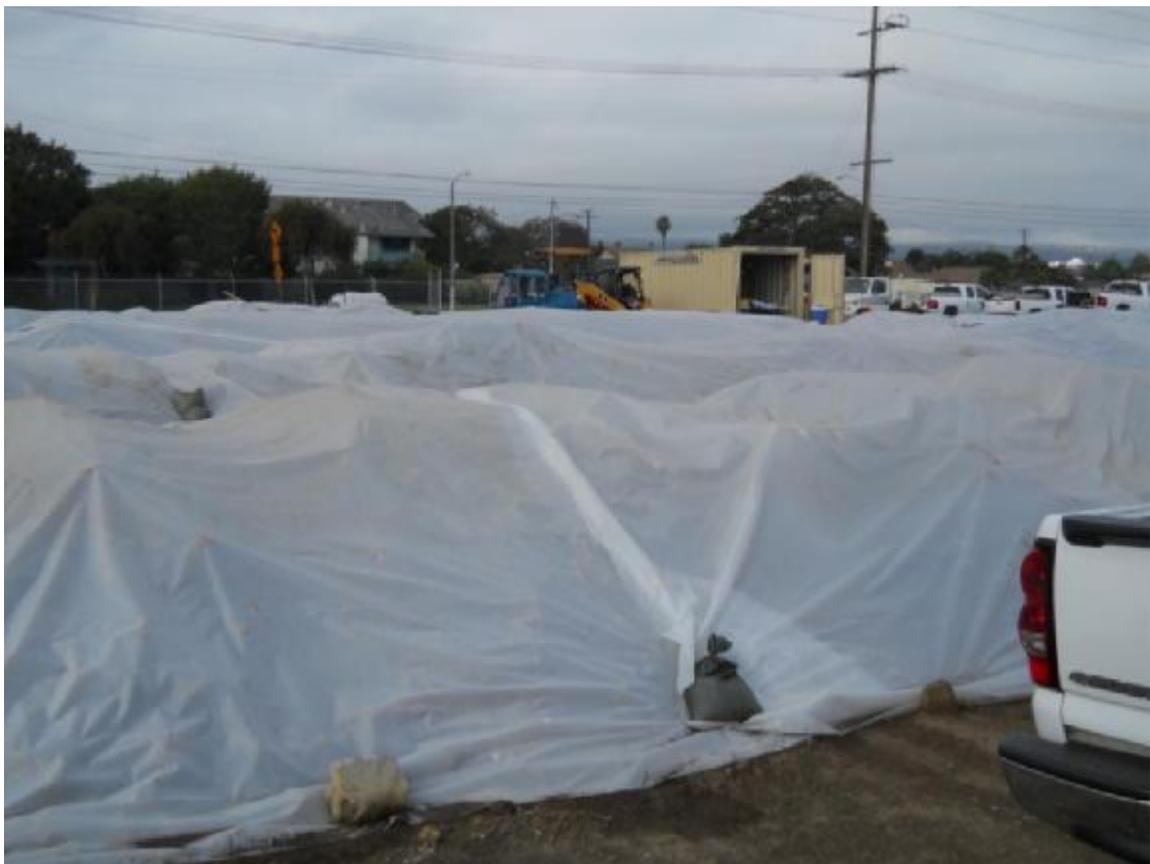
Figure 1: Covered stock piles at Waste Management site.

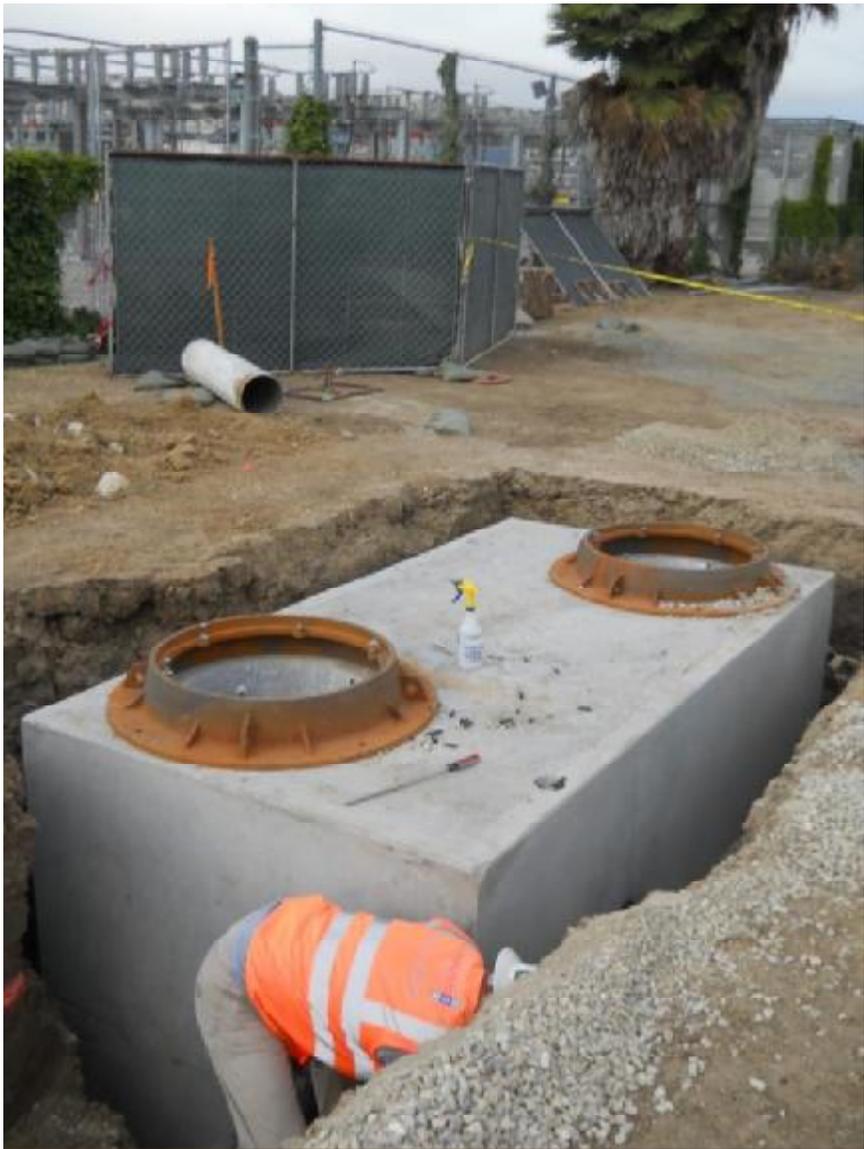
Figure 2: Injection Well 2 (IW2)

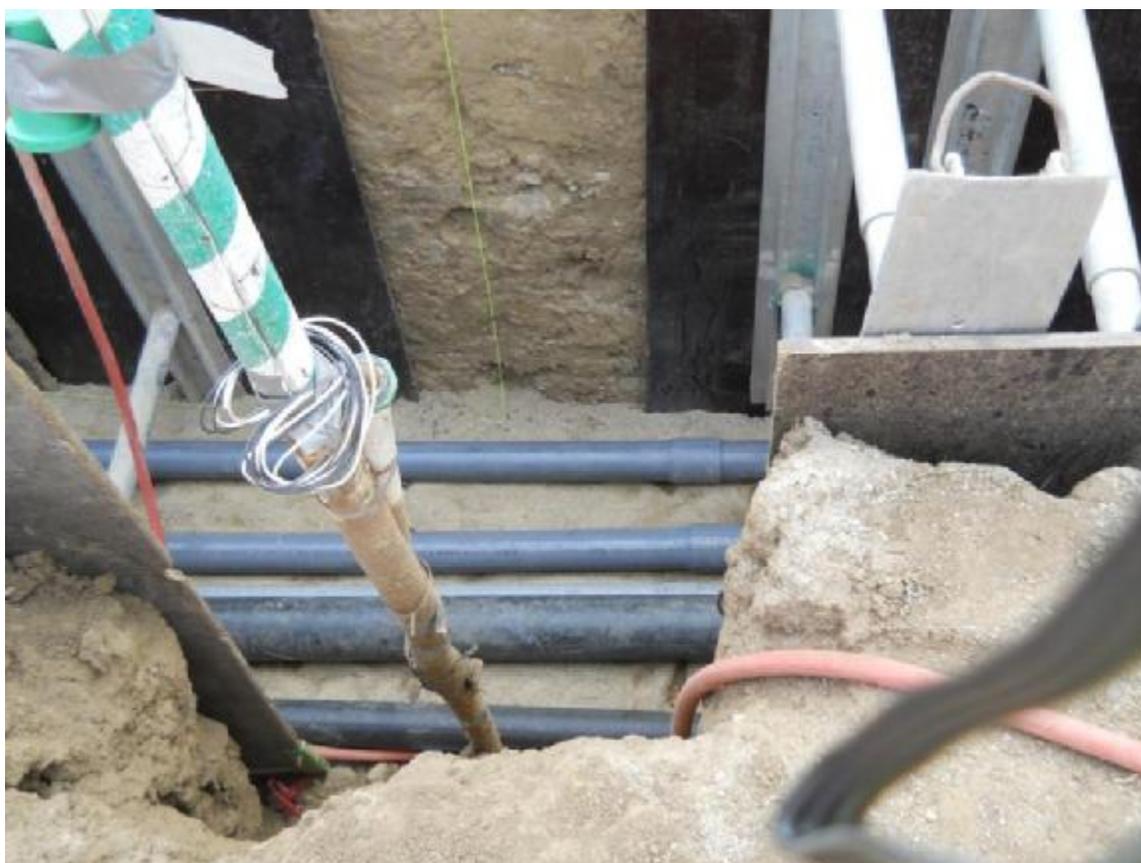
Figure 3: Close-up view of pipes in trench with shoring

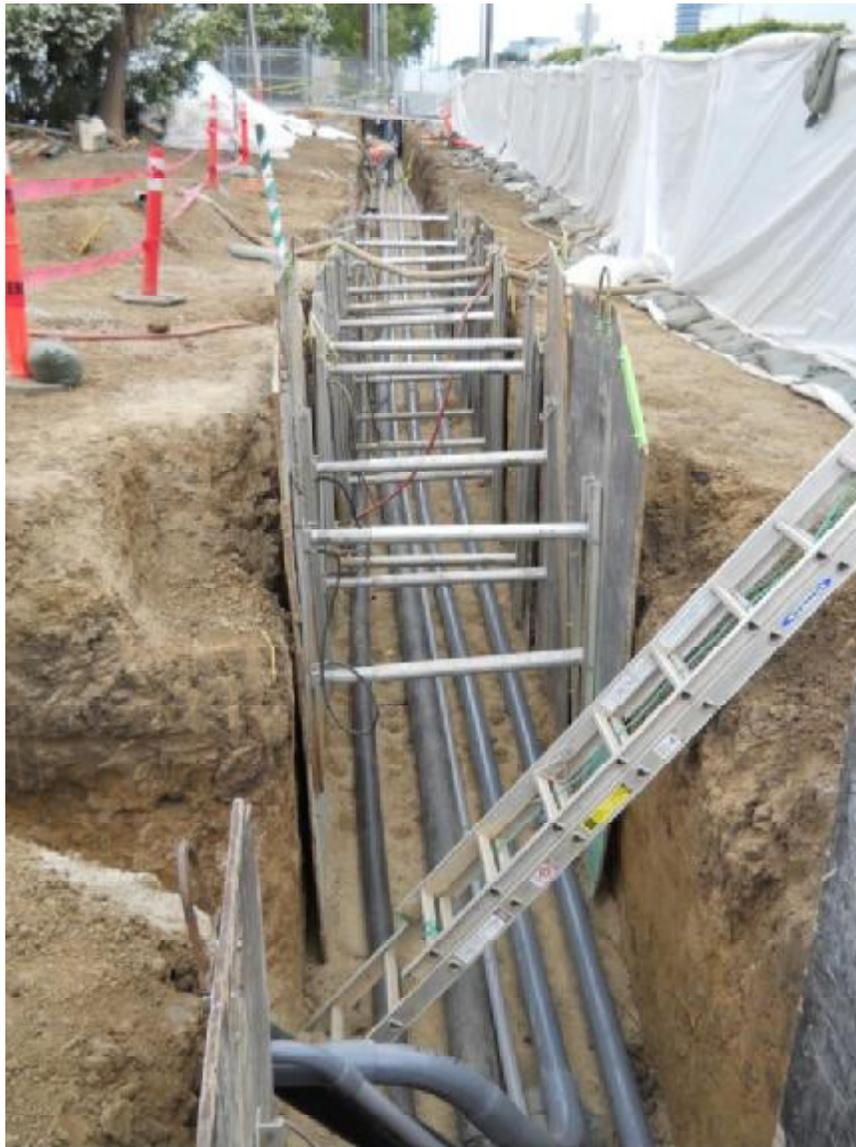
Figure 4: Pipes in trench with shoring

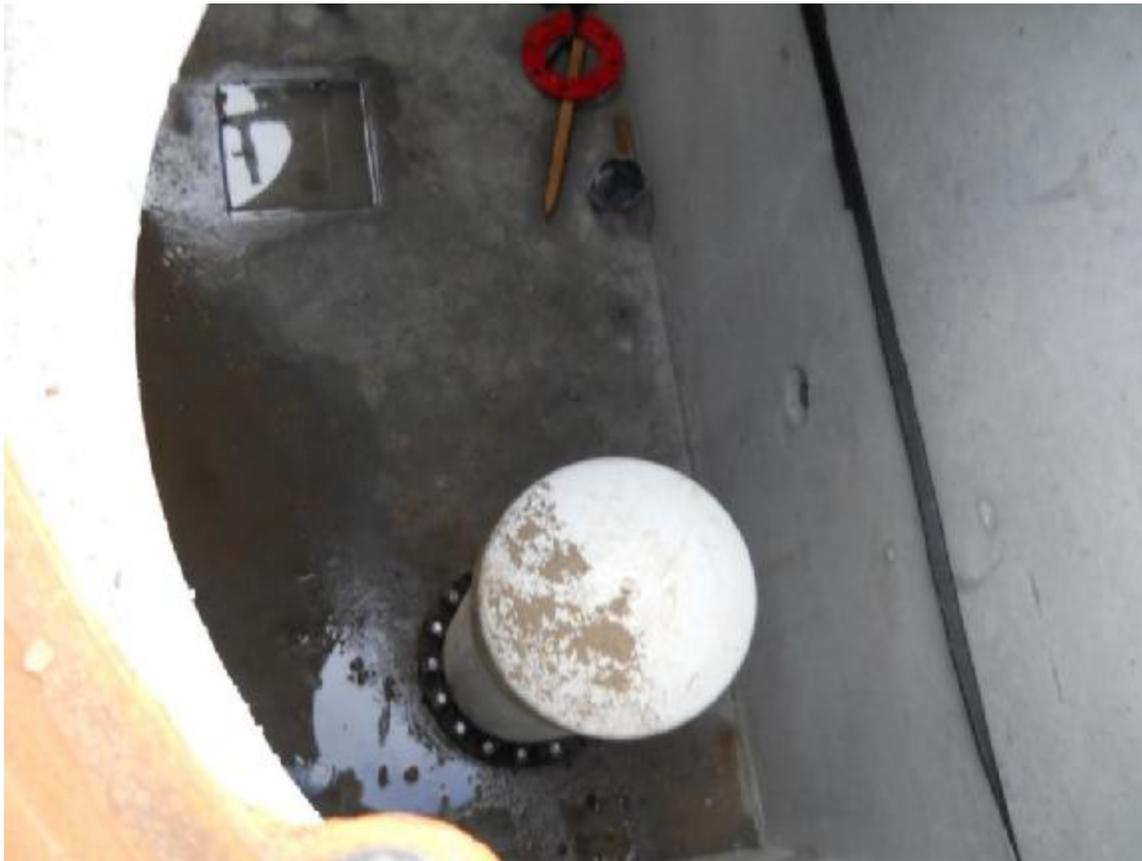
Figure 5: Inside IW5 with pressure gauges

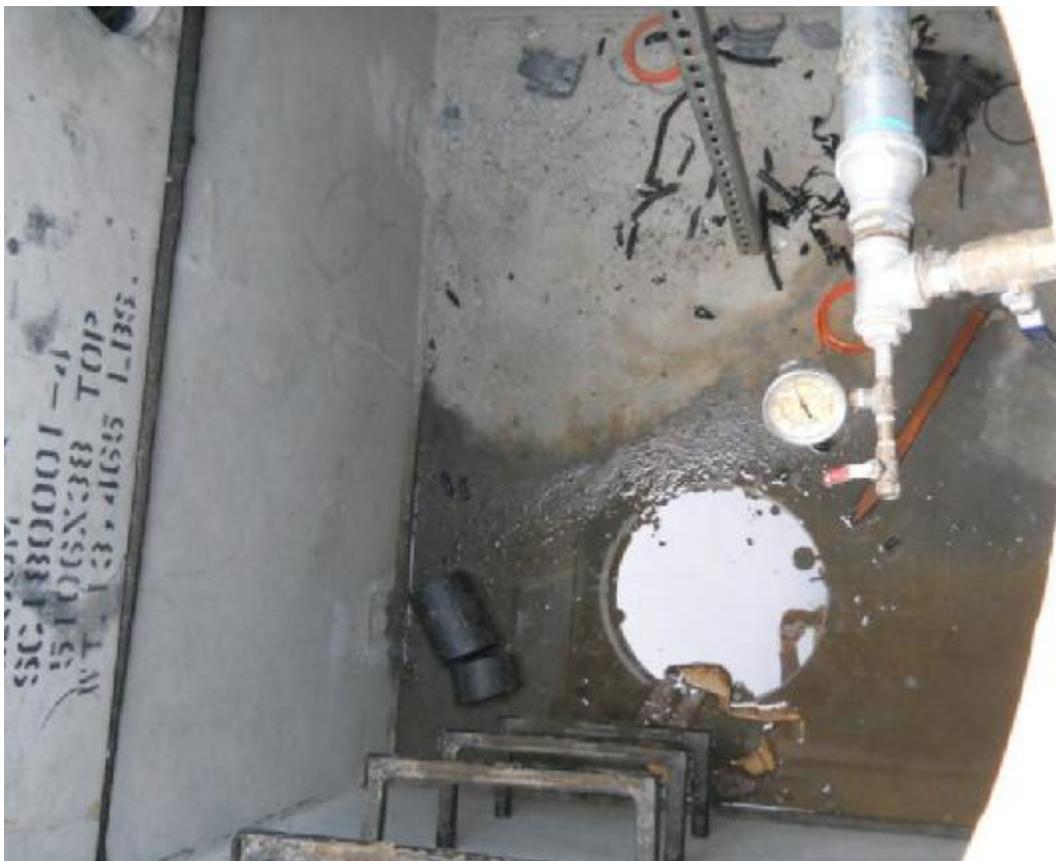
Figure 6: Pressure gauge for 4-inch Injection line with 6-inch header

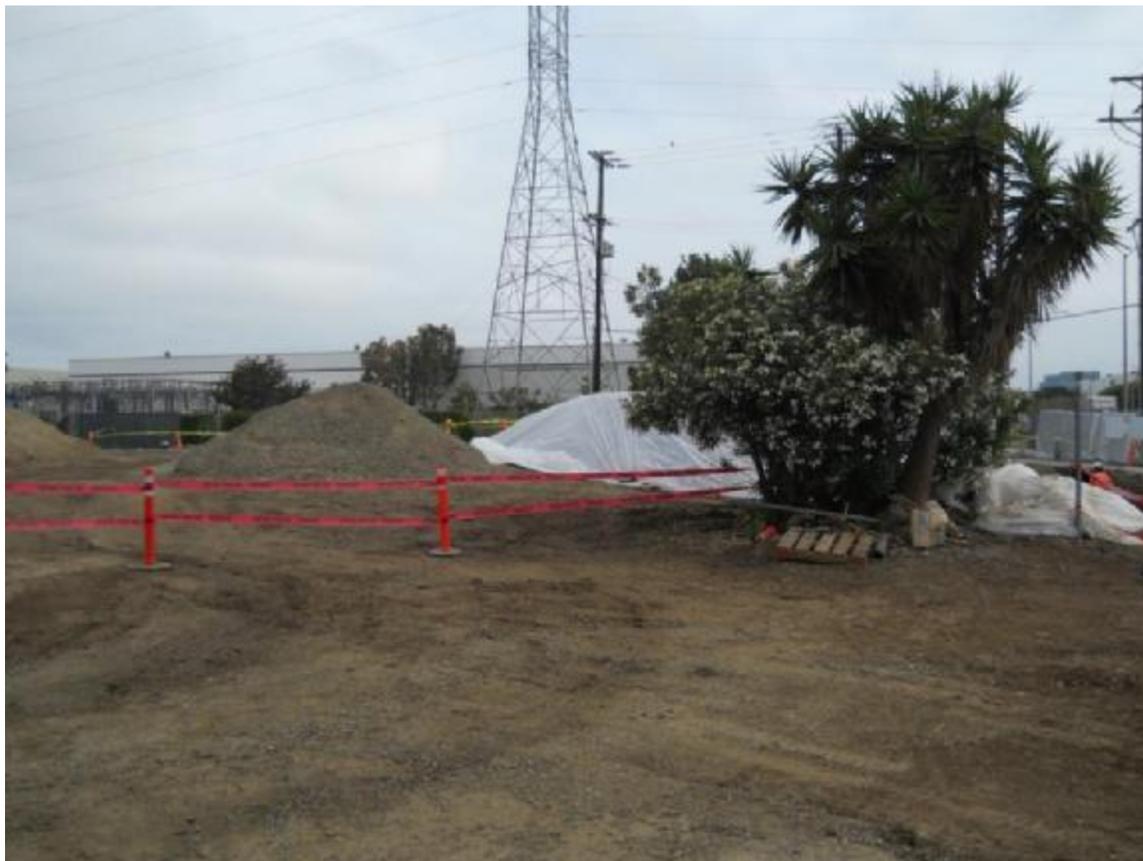
Figure 7: Gravel stockpile and covered soil stockpile

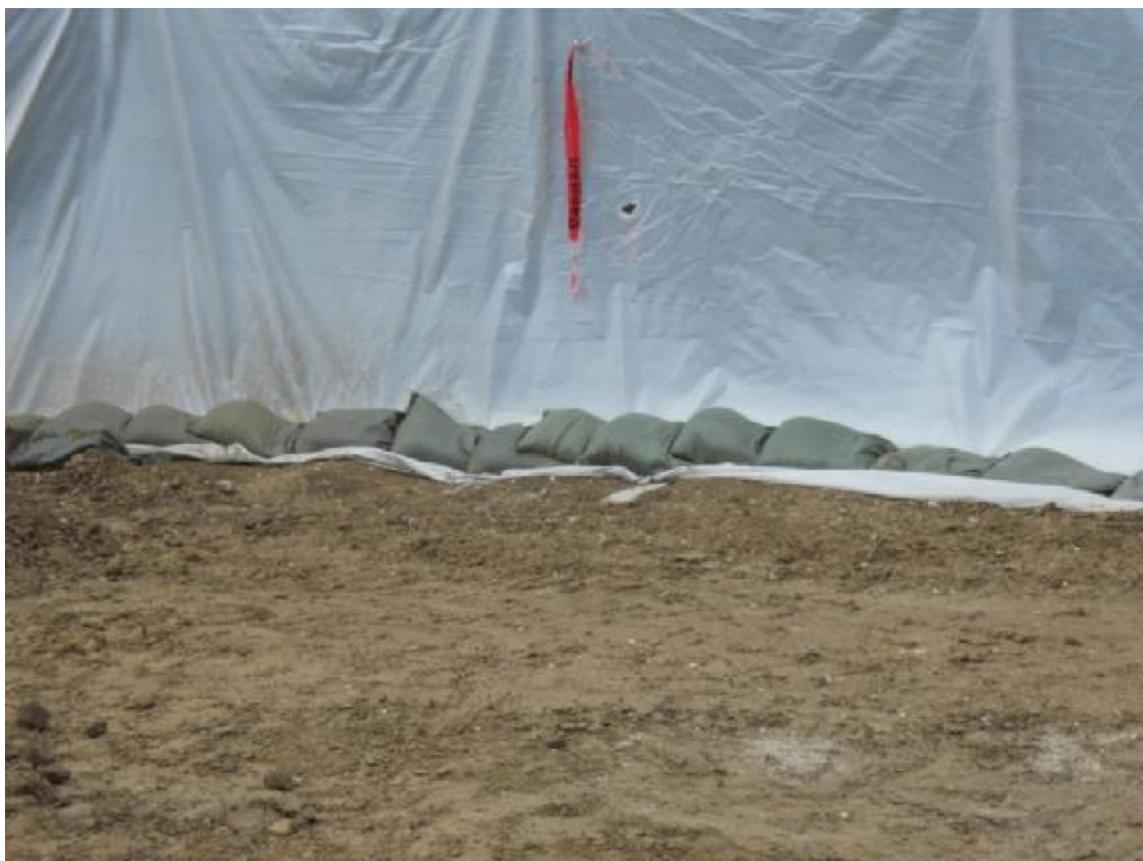
Figure 8: Property line fence with plastic to prevent dust migration

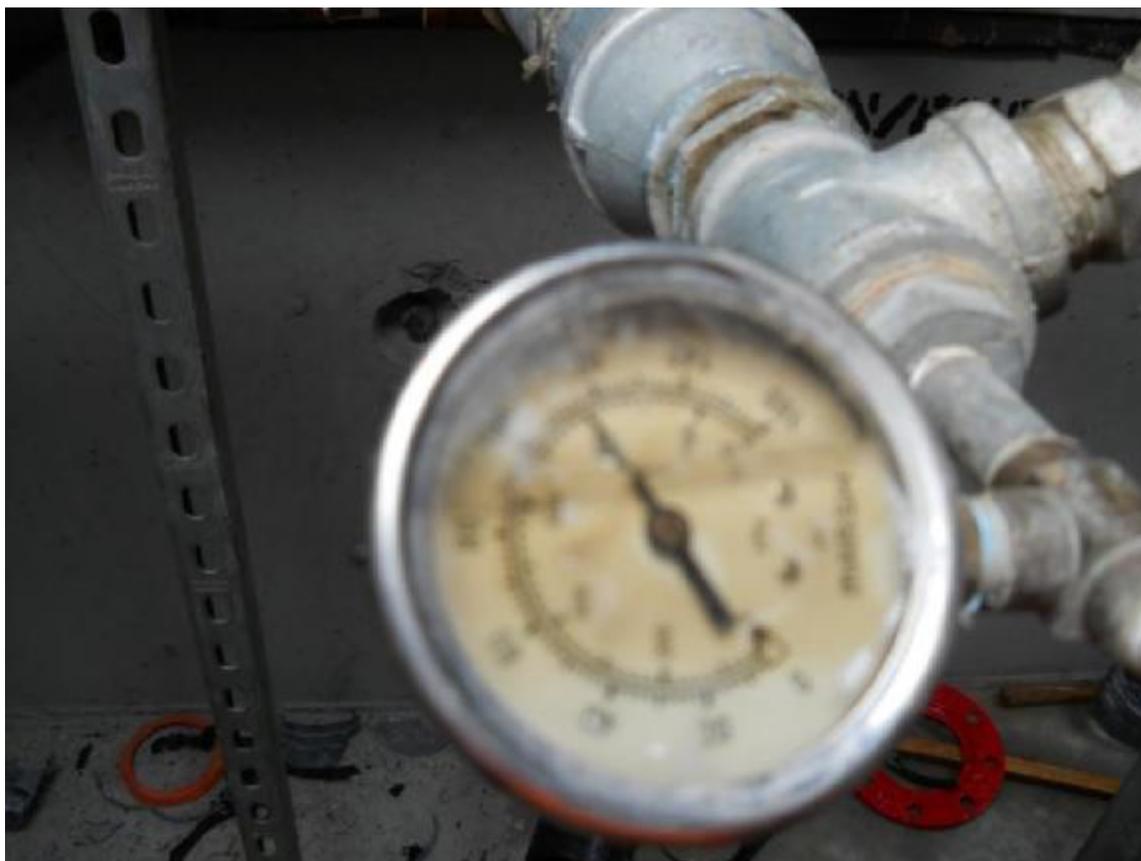
Figure 9: Close-up view of pressure gauge for 4" injection line with 6" header

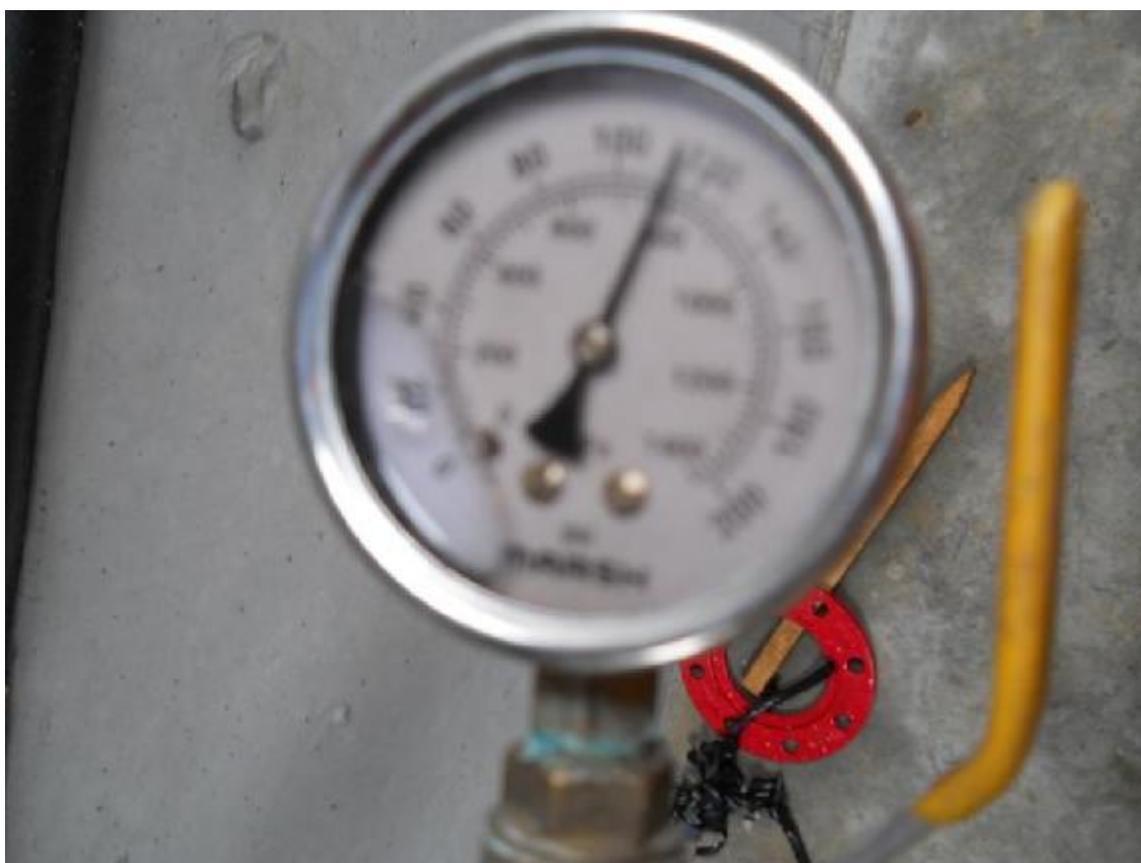
Figure 10: Close-up view of pressure gauge on 4-inch redevelopment return line

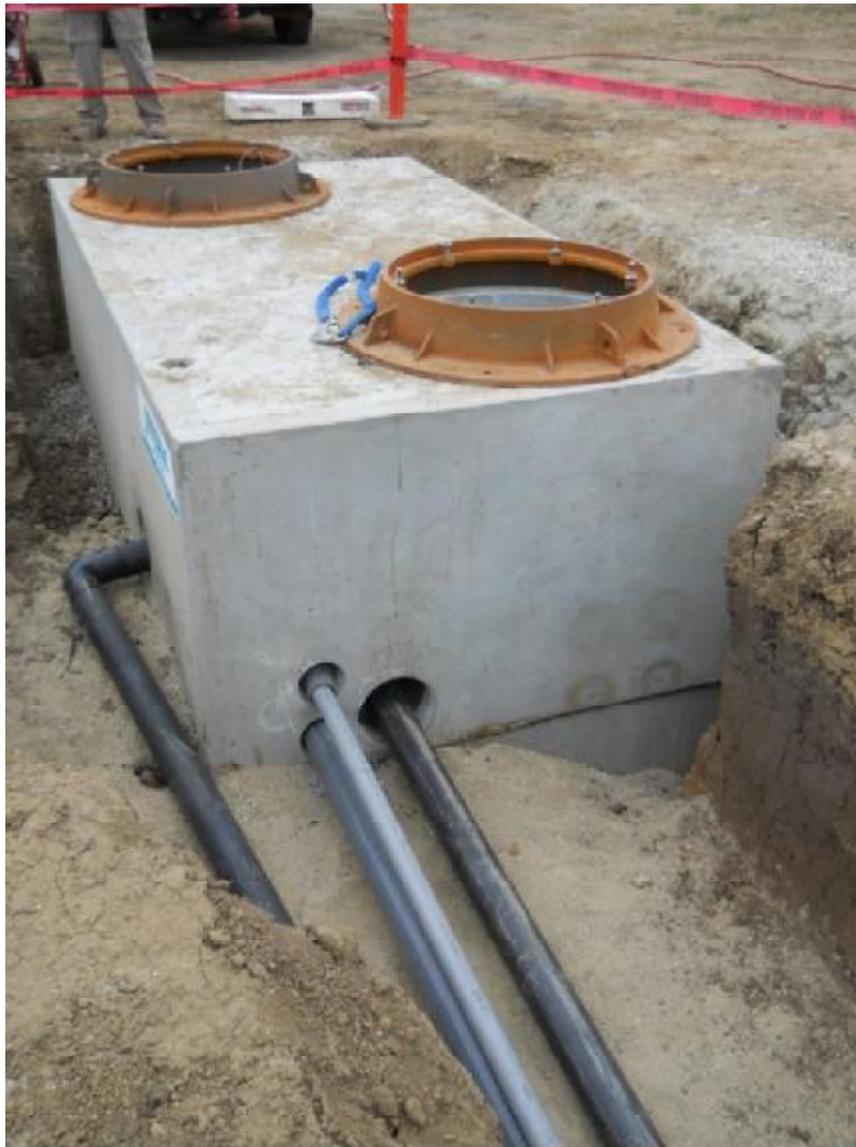
Figure 11: Precast vault that contained the pressure gauges

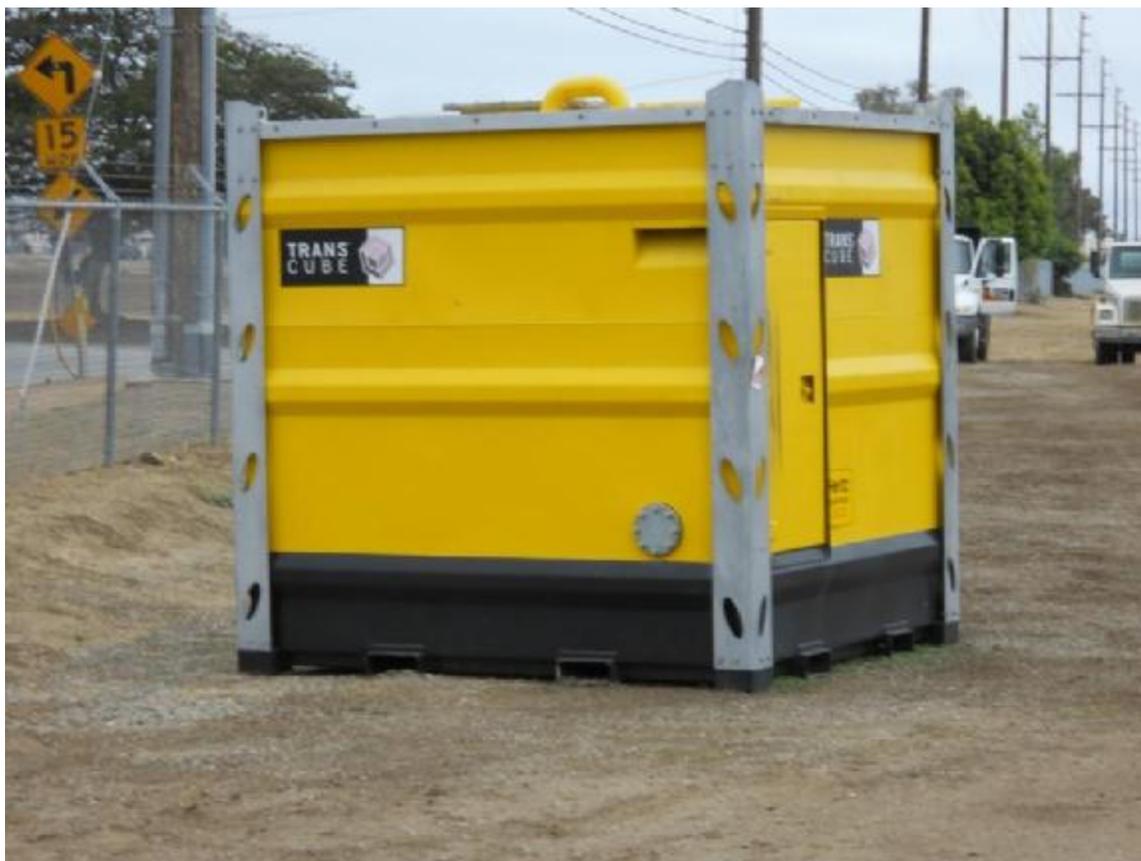
Figure 12: Portable storage container used to store fuel for diesel powered pumps during injection testing

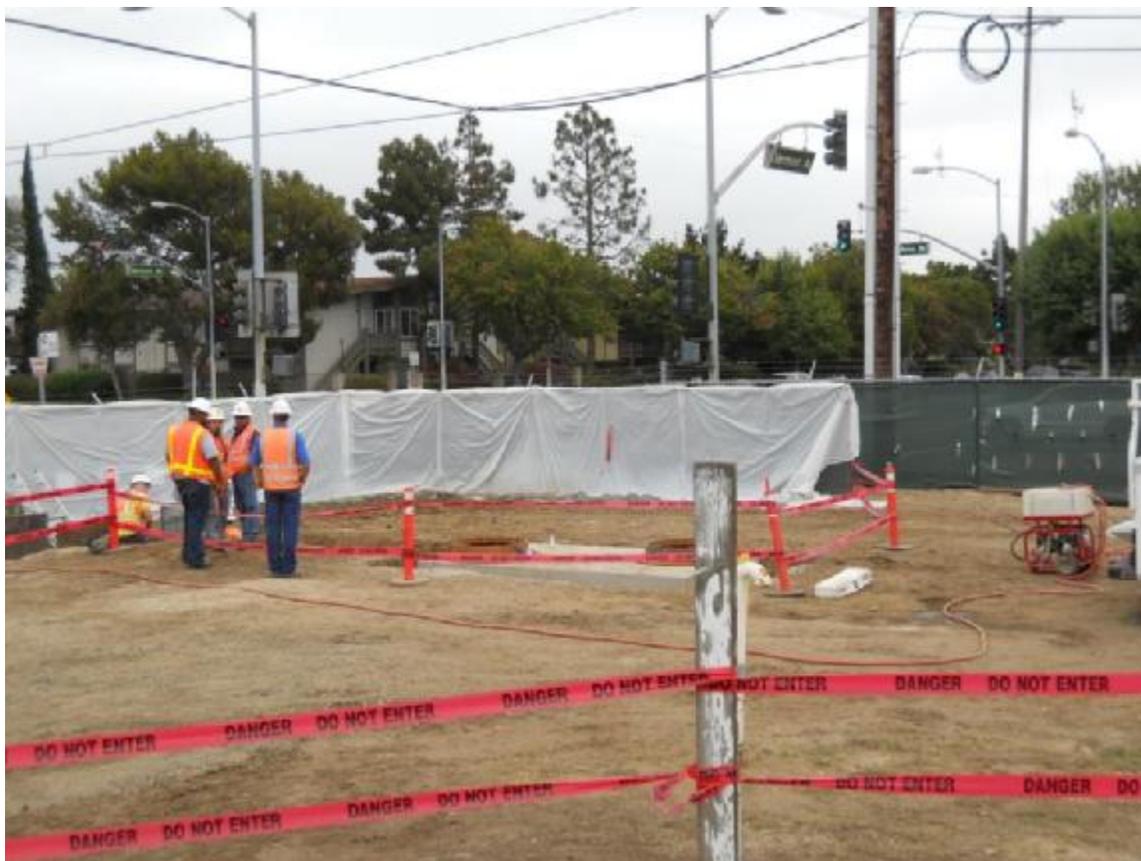
Figure 13: General site view of Injection Well 5

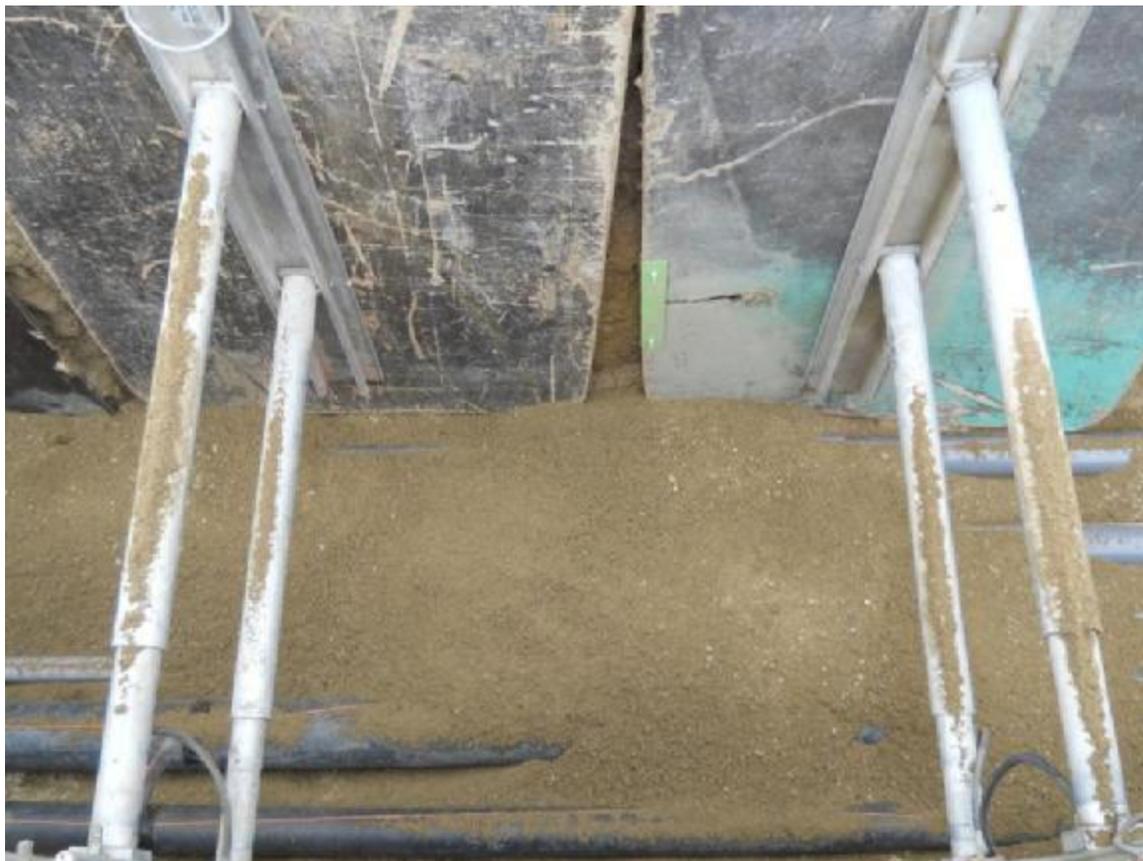
Figure 14: Trench with some sand backfill

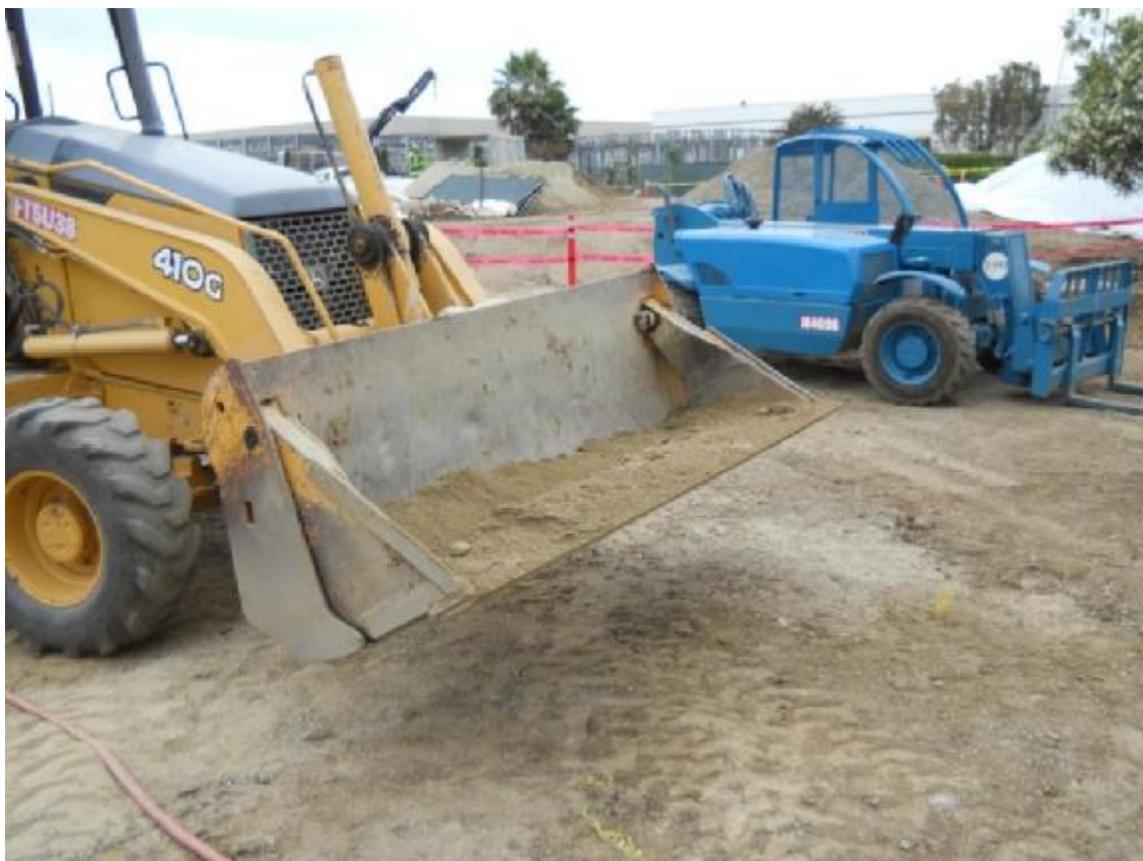
Figure 15: Loader with bucket of sand to begin backfill

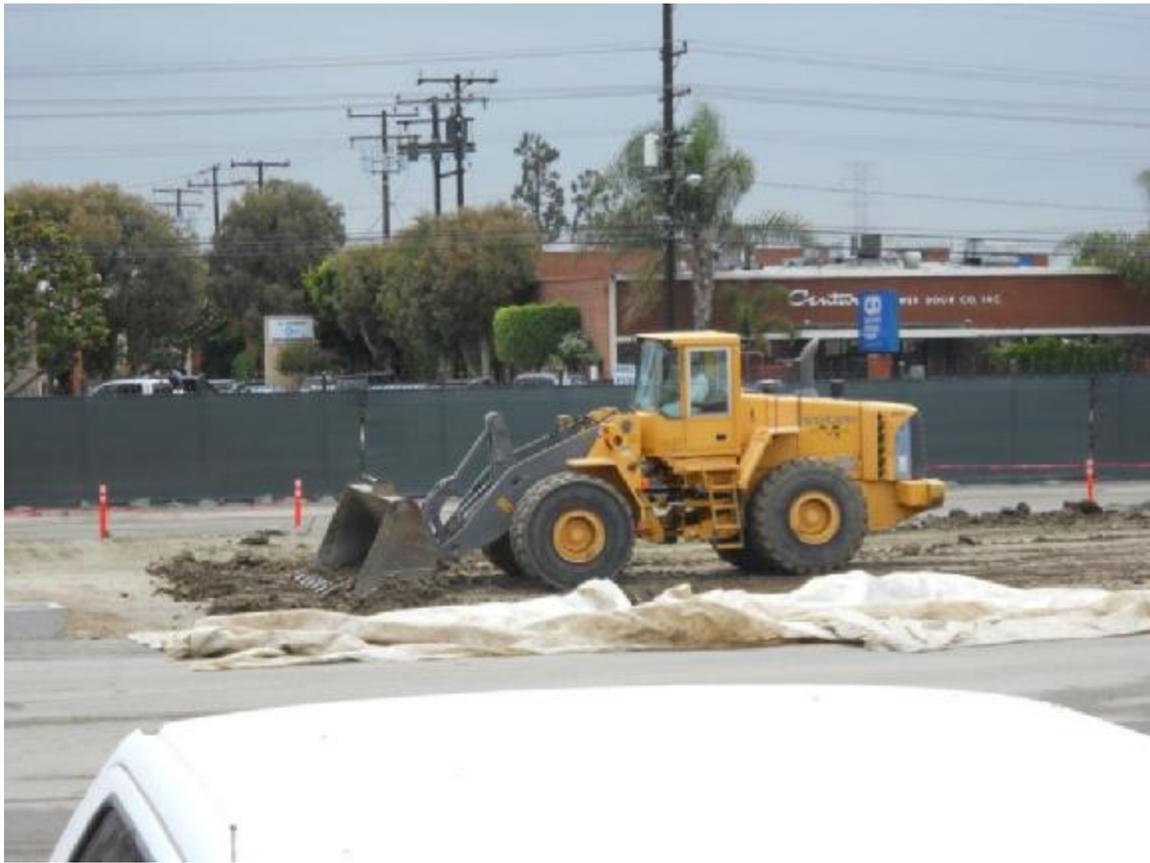
Figure 16: Montrose site grading in progress

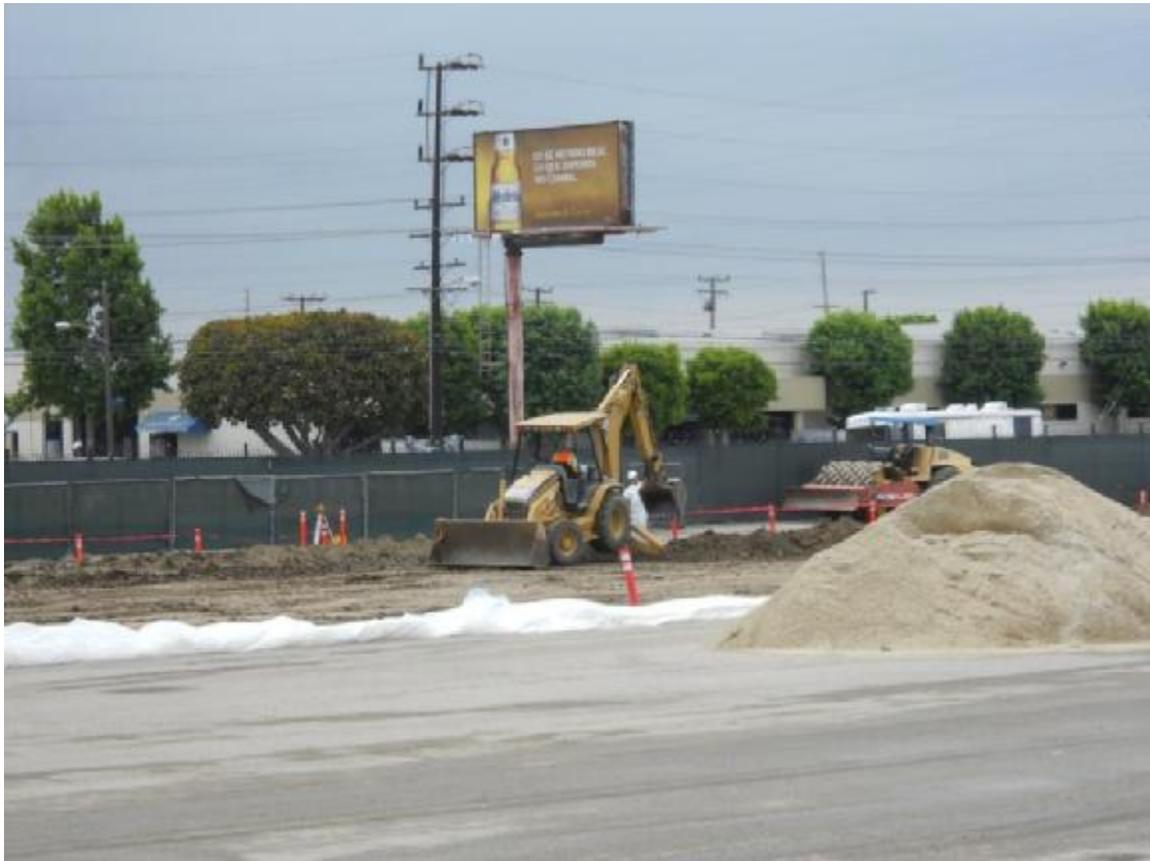
Figure 17: Montrose site trenching in progress

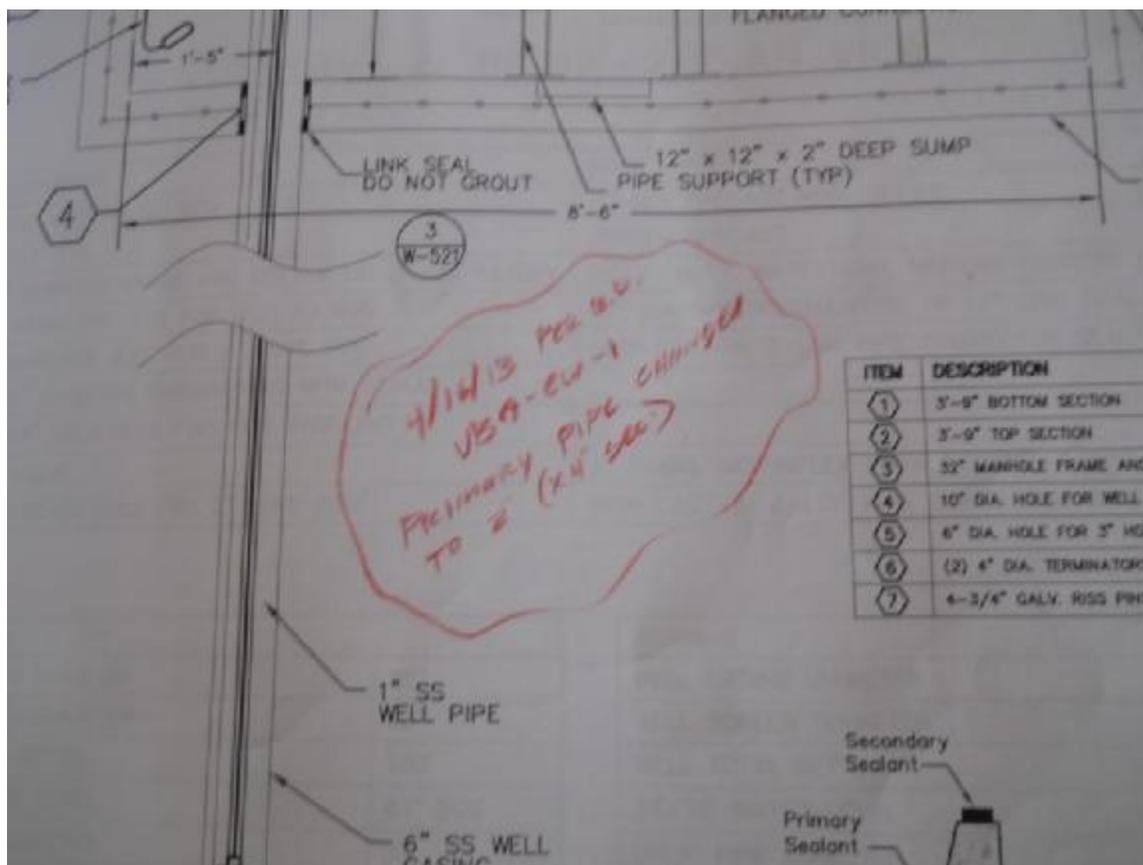
B) Issues concerning conformance to specifications and/or design:
 The three (3) well heads and trenches that were installed were different than originally designed but in accordance with a redesign in RFI 008, which were triggered by changes in the injection well positions.

Figure 18: Diameter change on well head due to higher than expected well production

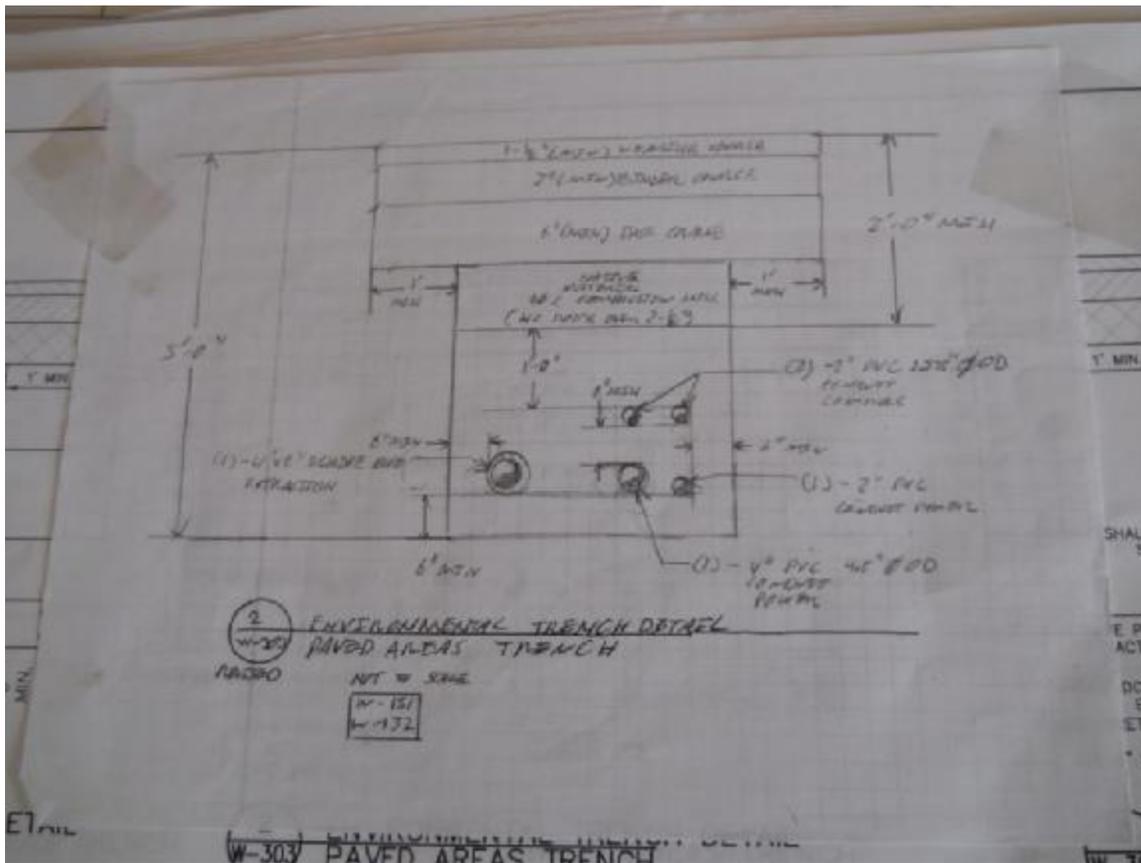
Figure 19: Modified Trench Layout

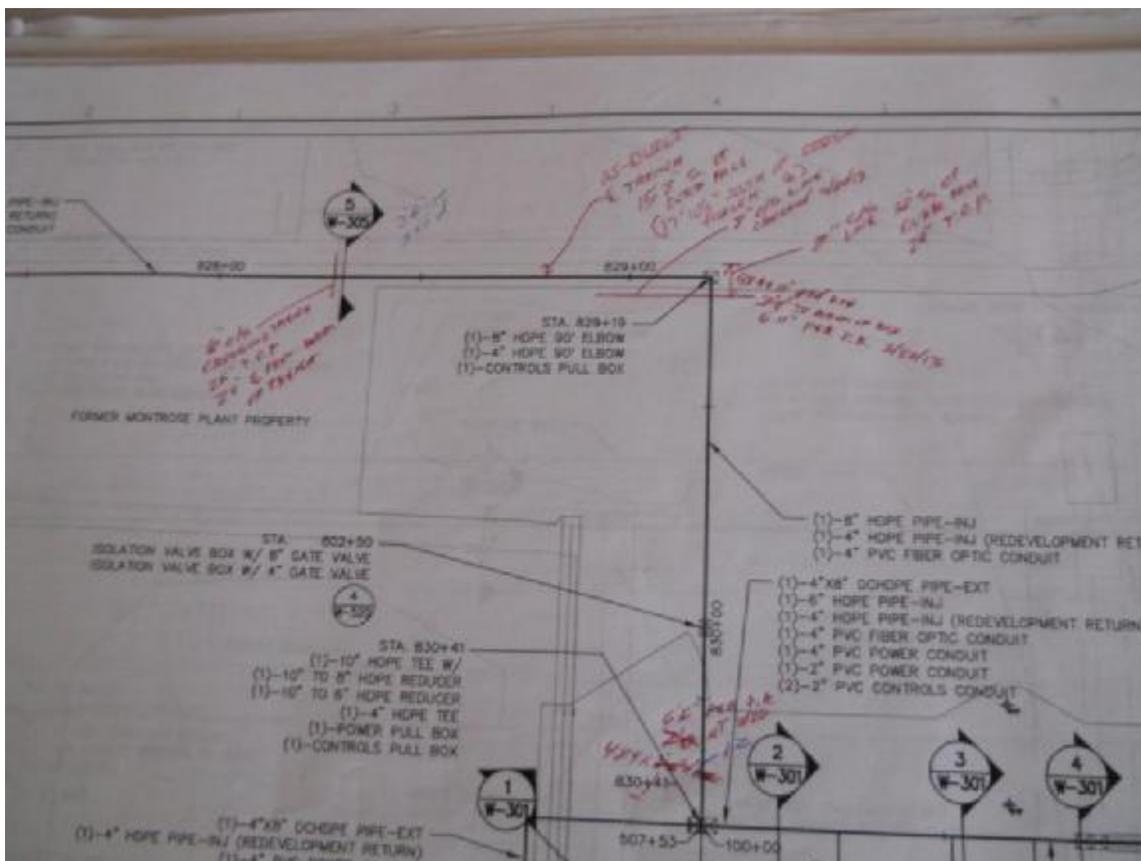
Figure 20: Realigned trench at north edge of Montrose site

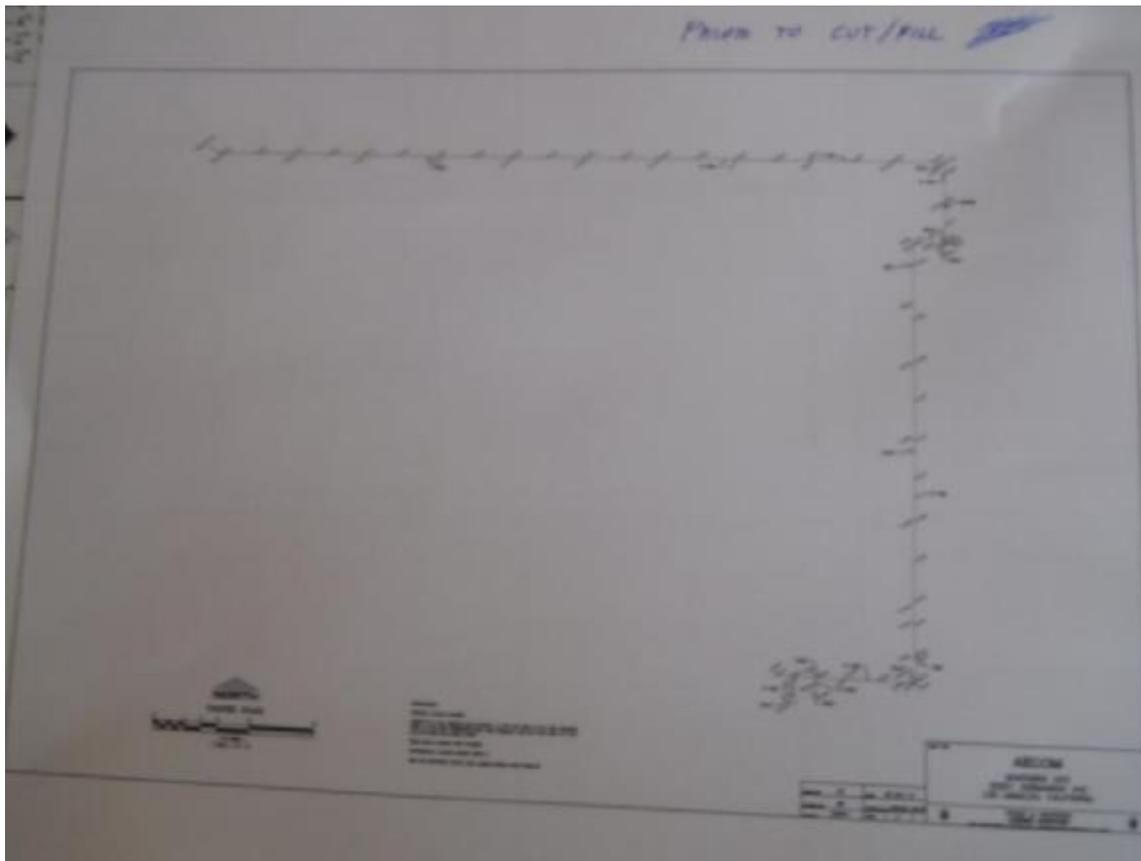
Figure 21: Record survey of realigned trench

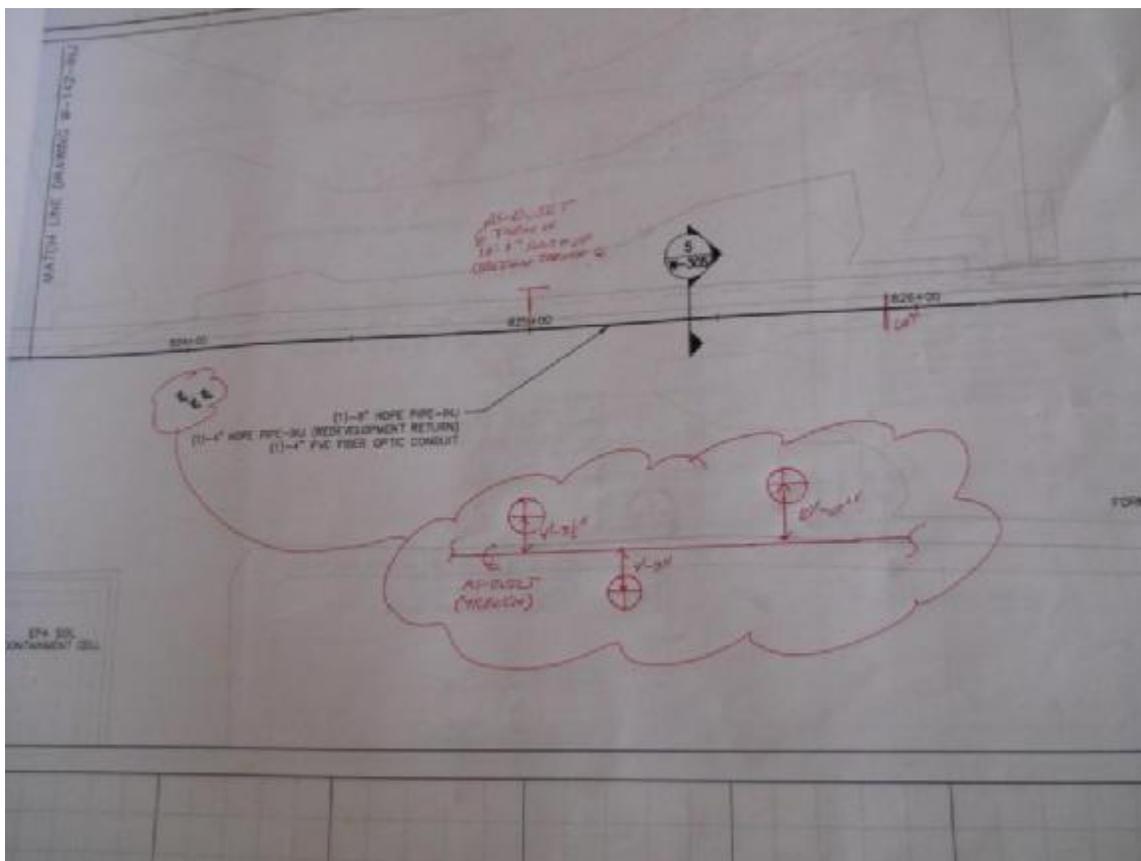
Figure 22: Realigned trench referenced to design trench

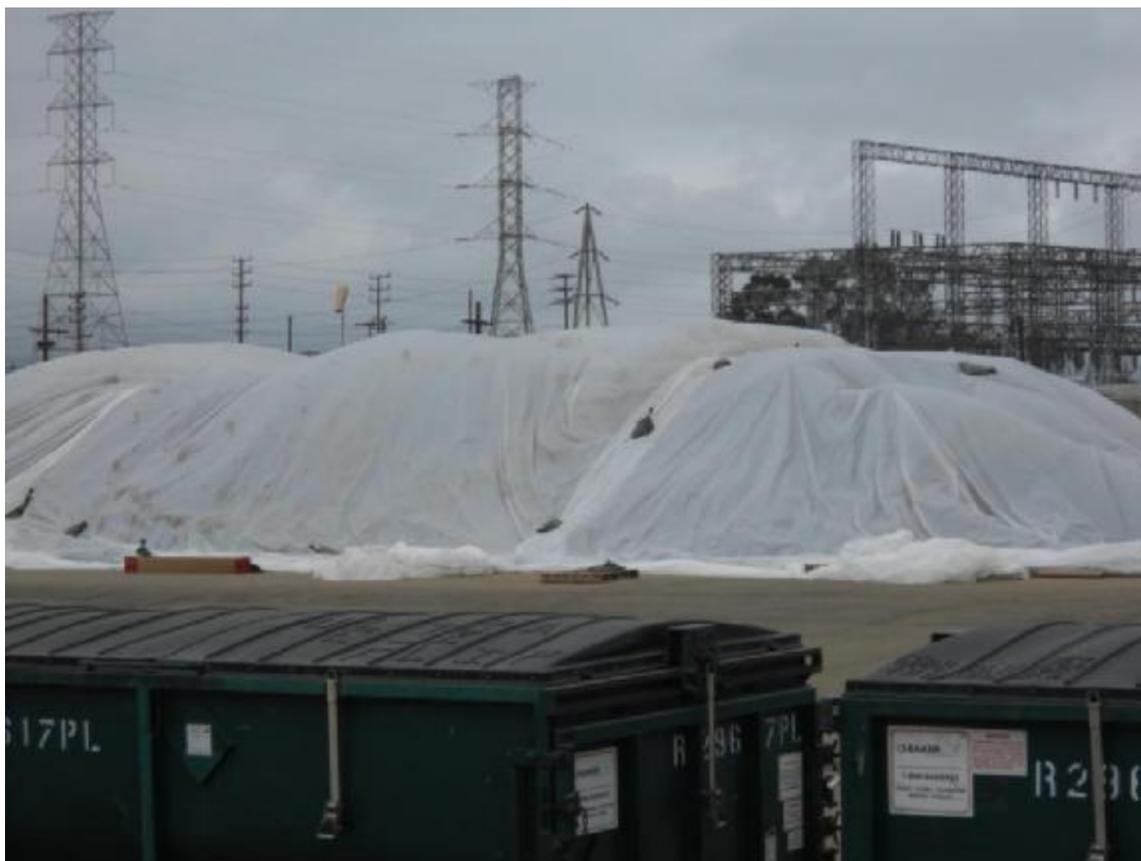
Figure 25: Covered stockpile at center of Montrose site
